# BUREAU OF SHIPS GROUP

## TECHNICAL INSPECTION REPORT

### U.S.S. SALT LAKE CITY (CA 25)

### TEST BAKER

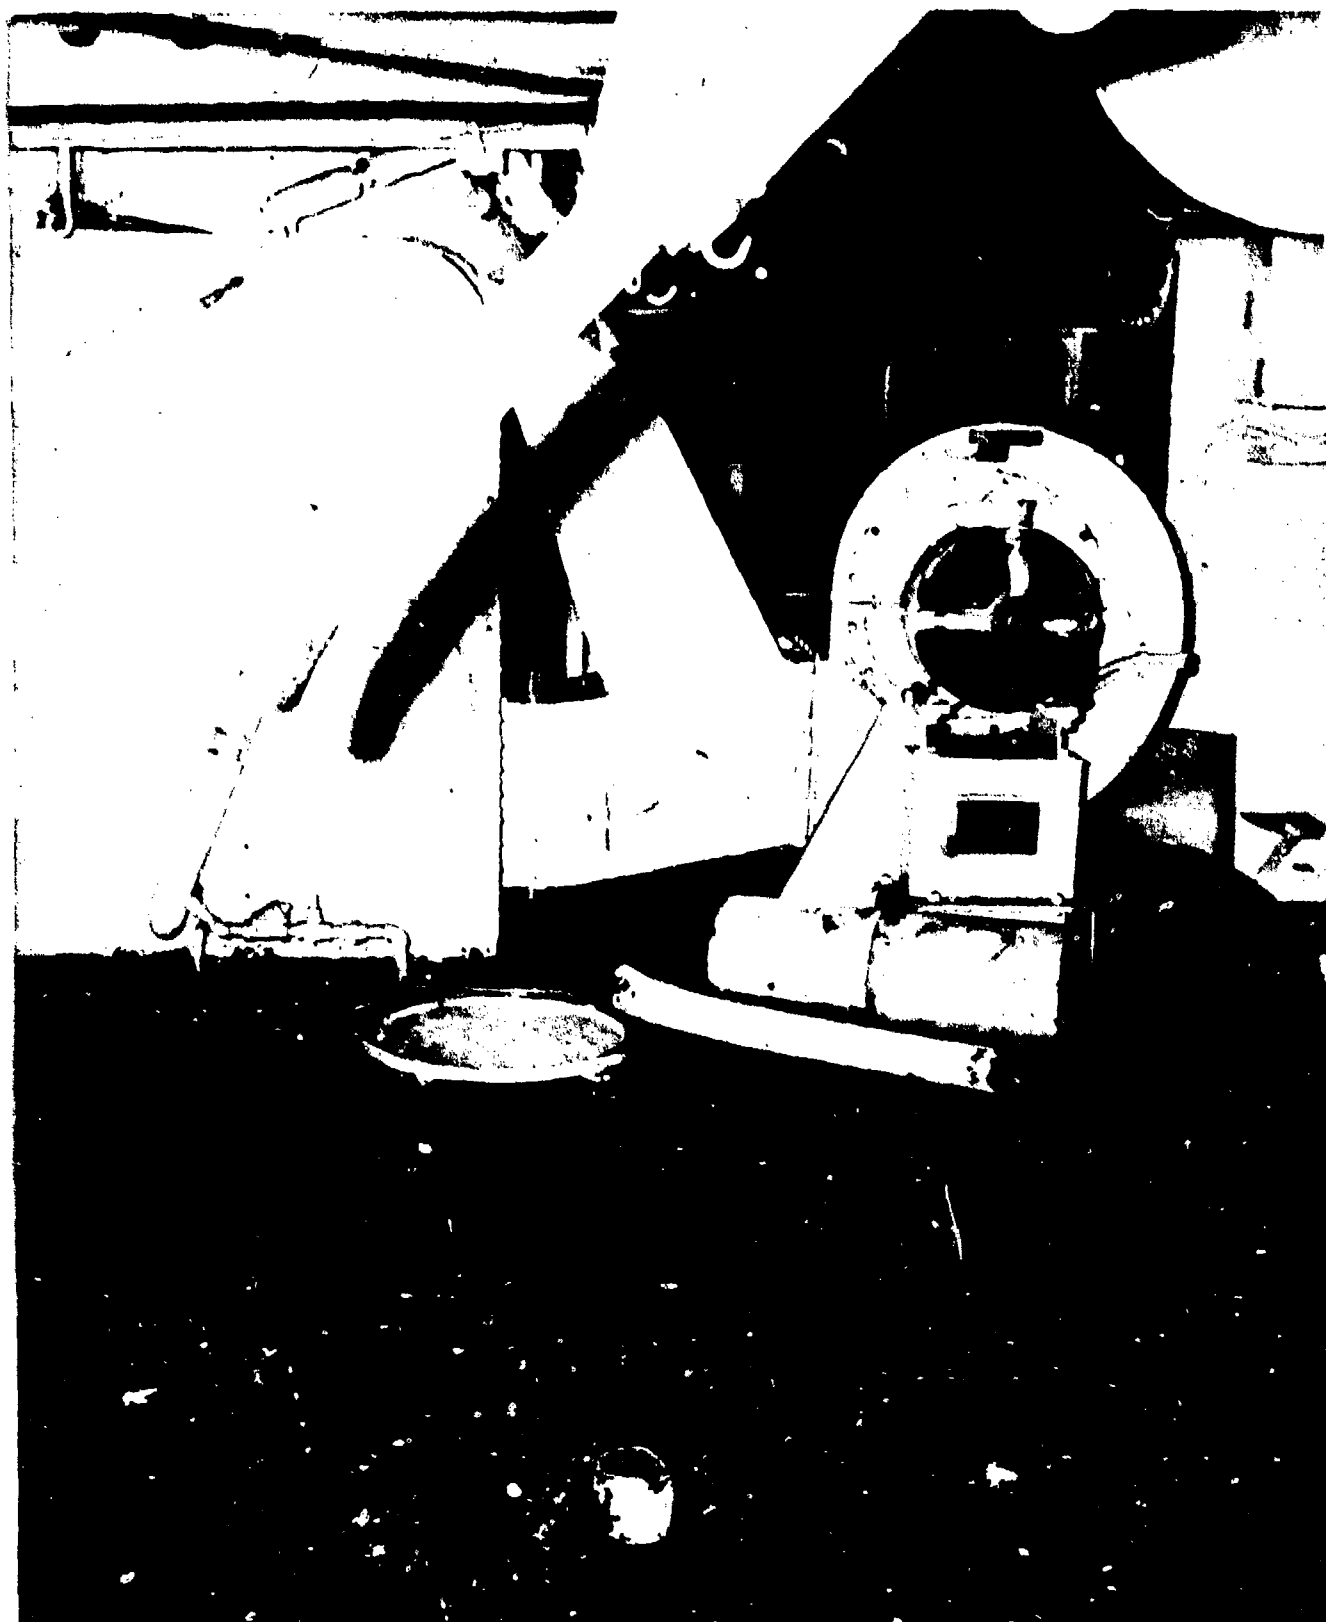
The only visible structural damage above the second (armor) deck is the fractured stanchions at frames 65, 68, and 97. (Photos 1718-8, 9, 10, 11, 12, 1710-1; pages 84 , 85 , 86 , 87 , 88 , and 89 ).

AB-CR-65-1718-10. C-201L. Fracture of centerline stanchion under main deck transverse girder at frame 68. Compare with 1894-8, 2102-10, and 2102-12 showing condition after Test A.

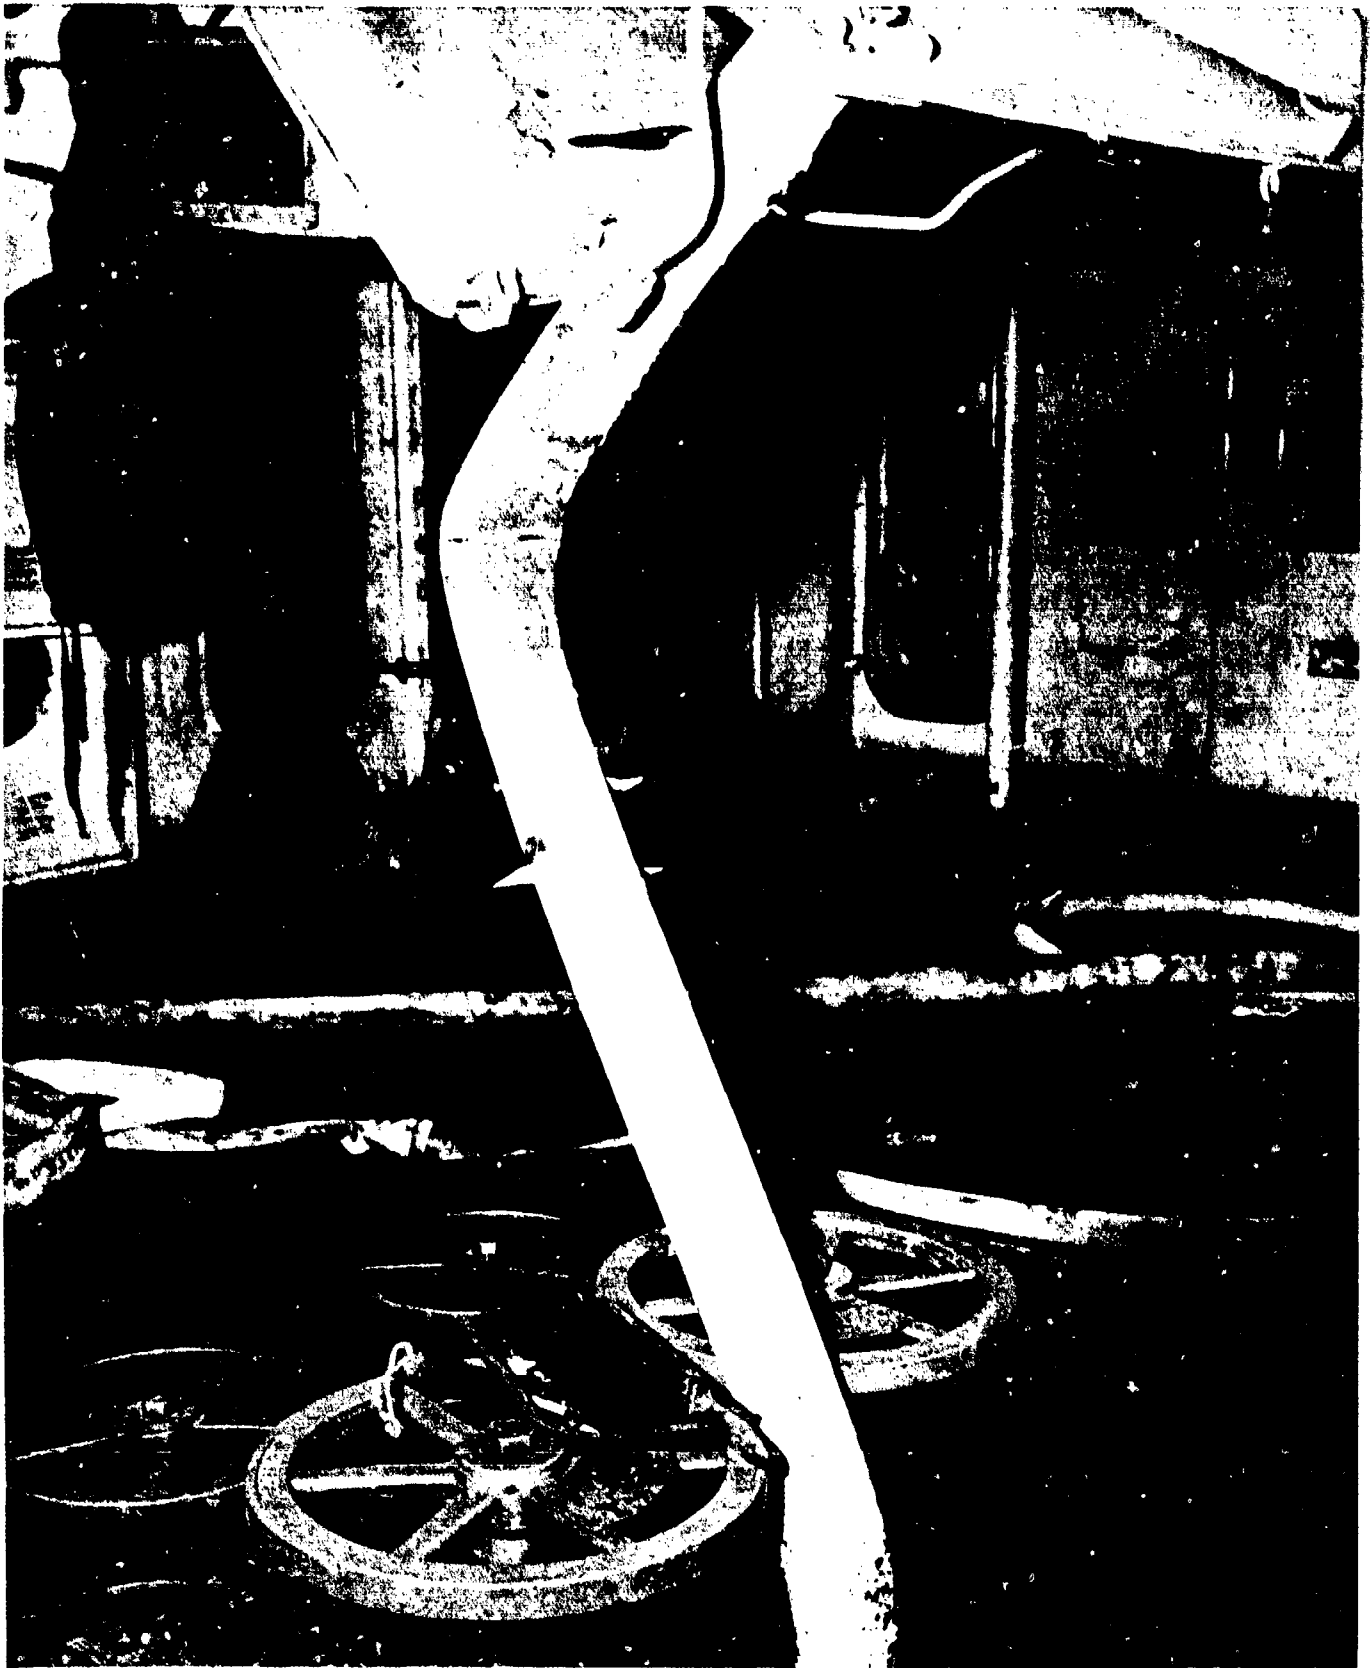
AB-CR-65-1718-11. C-201L. Fracture of centerline stanchion under main deck transverse girder at frame 65. Compare with 2102-3, 2102-4, 2102-5, and 1894-7. Showing condition after Test A.

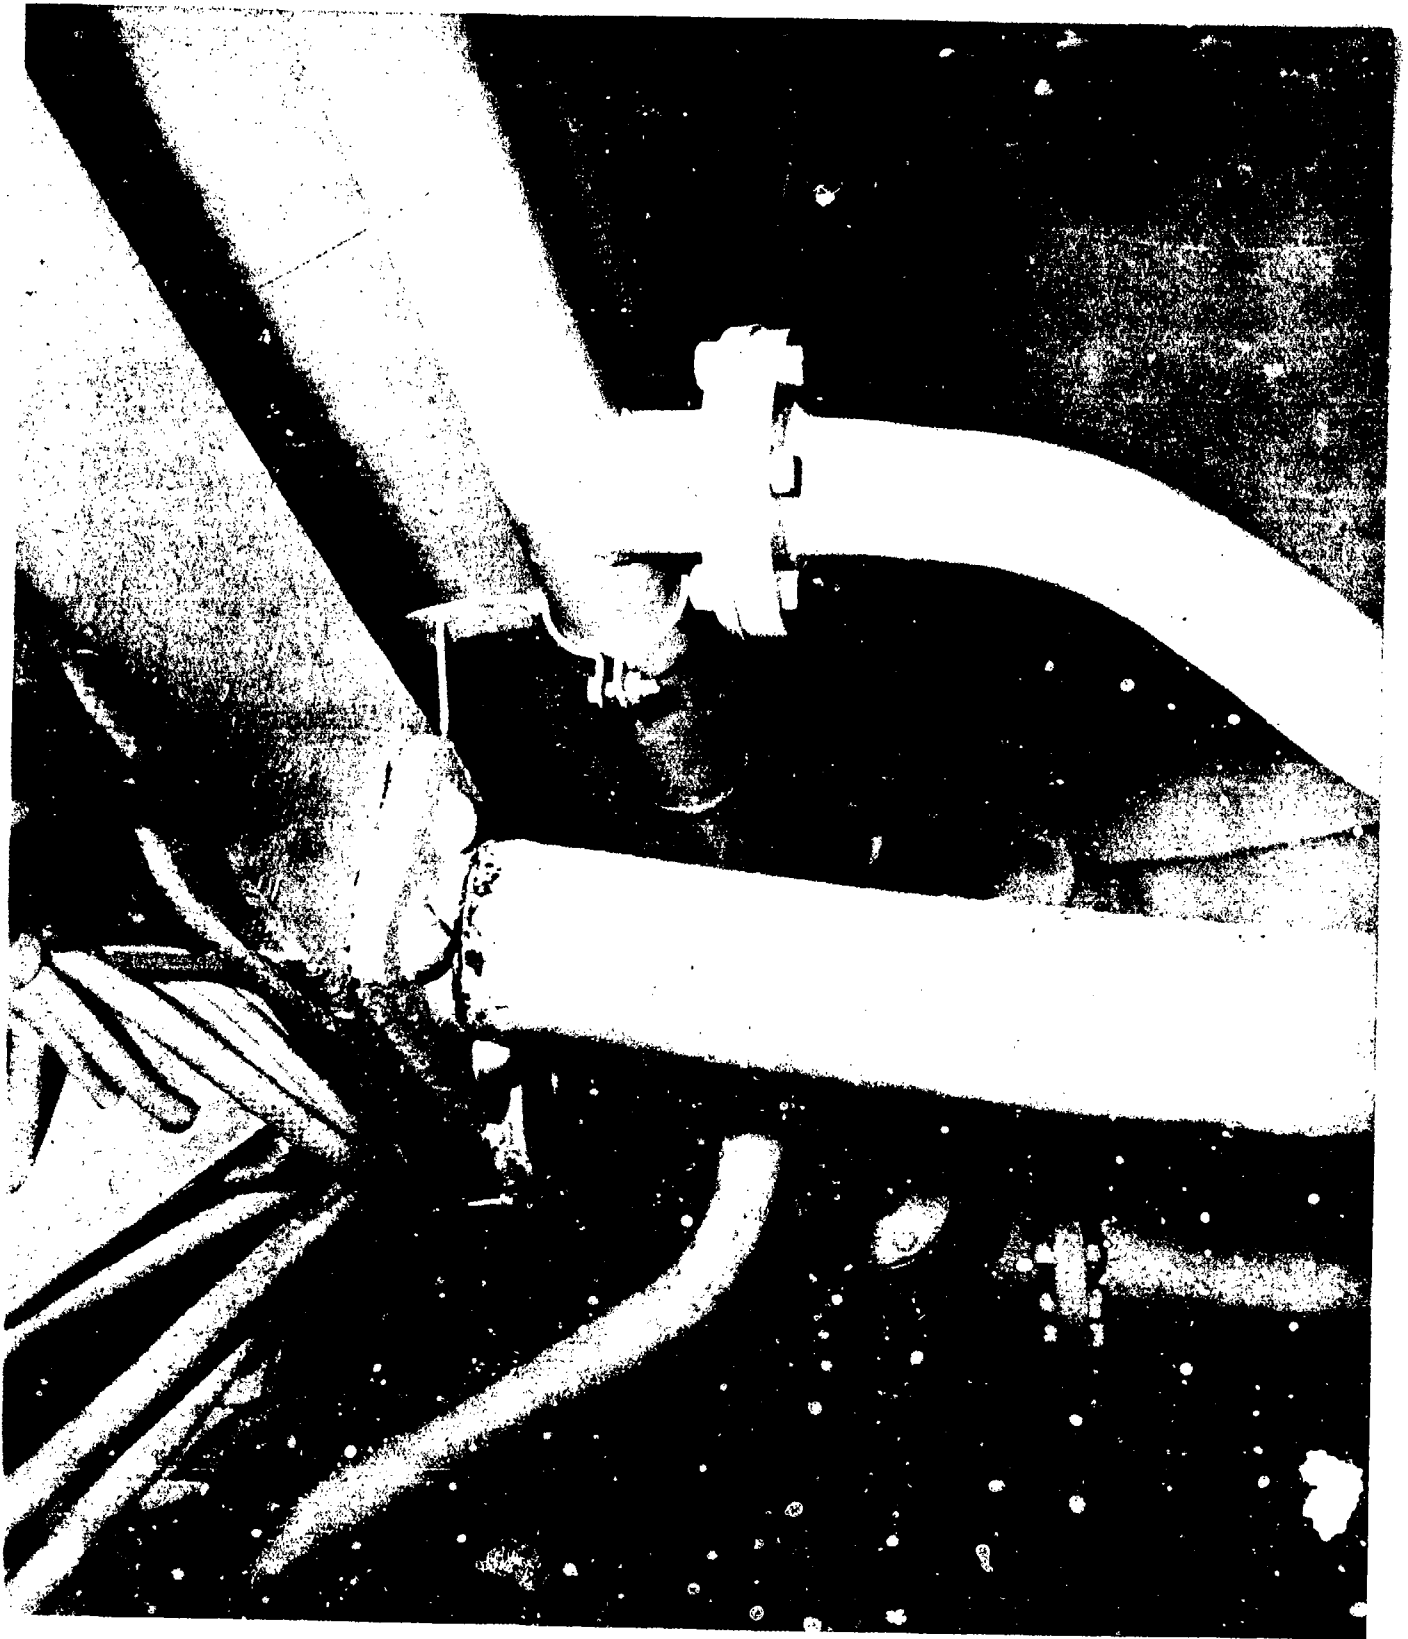
AB-CR-60-1710-1. Centerline stanchion at frame 97, second deck compressed and buckled during Test A, snapped during Test B.

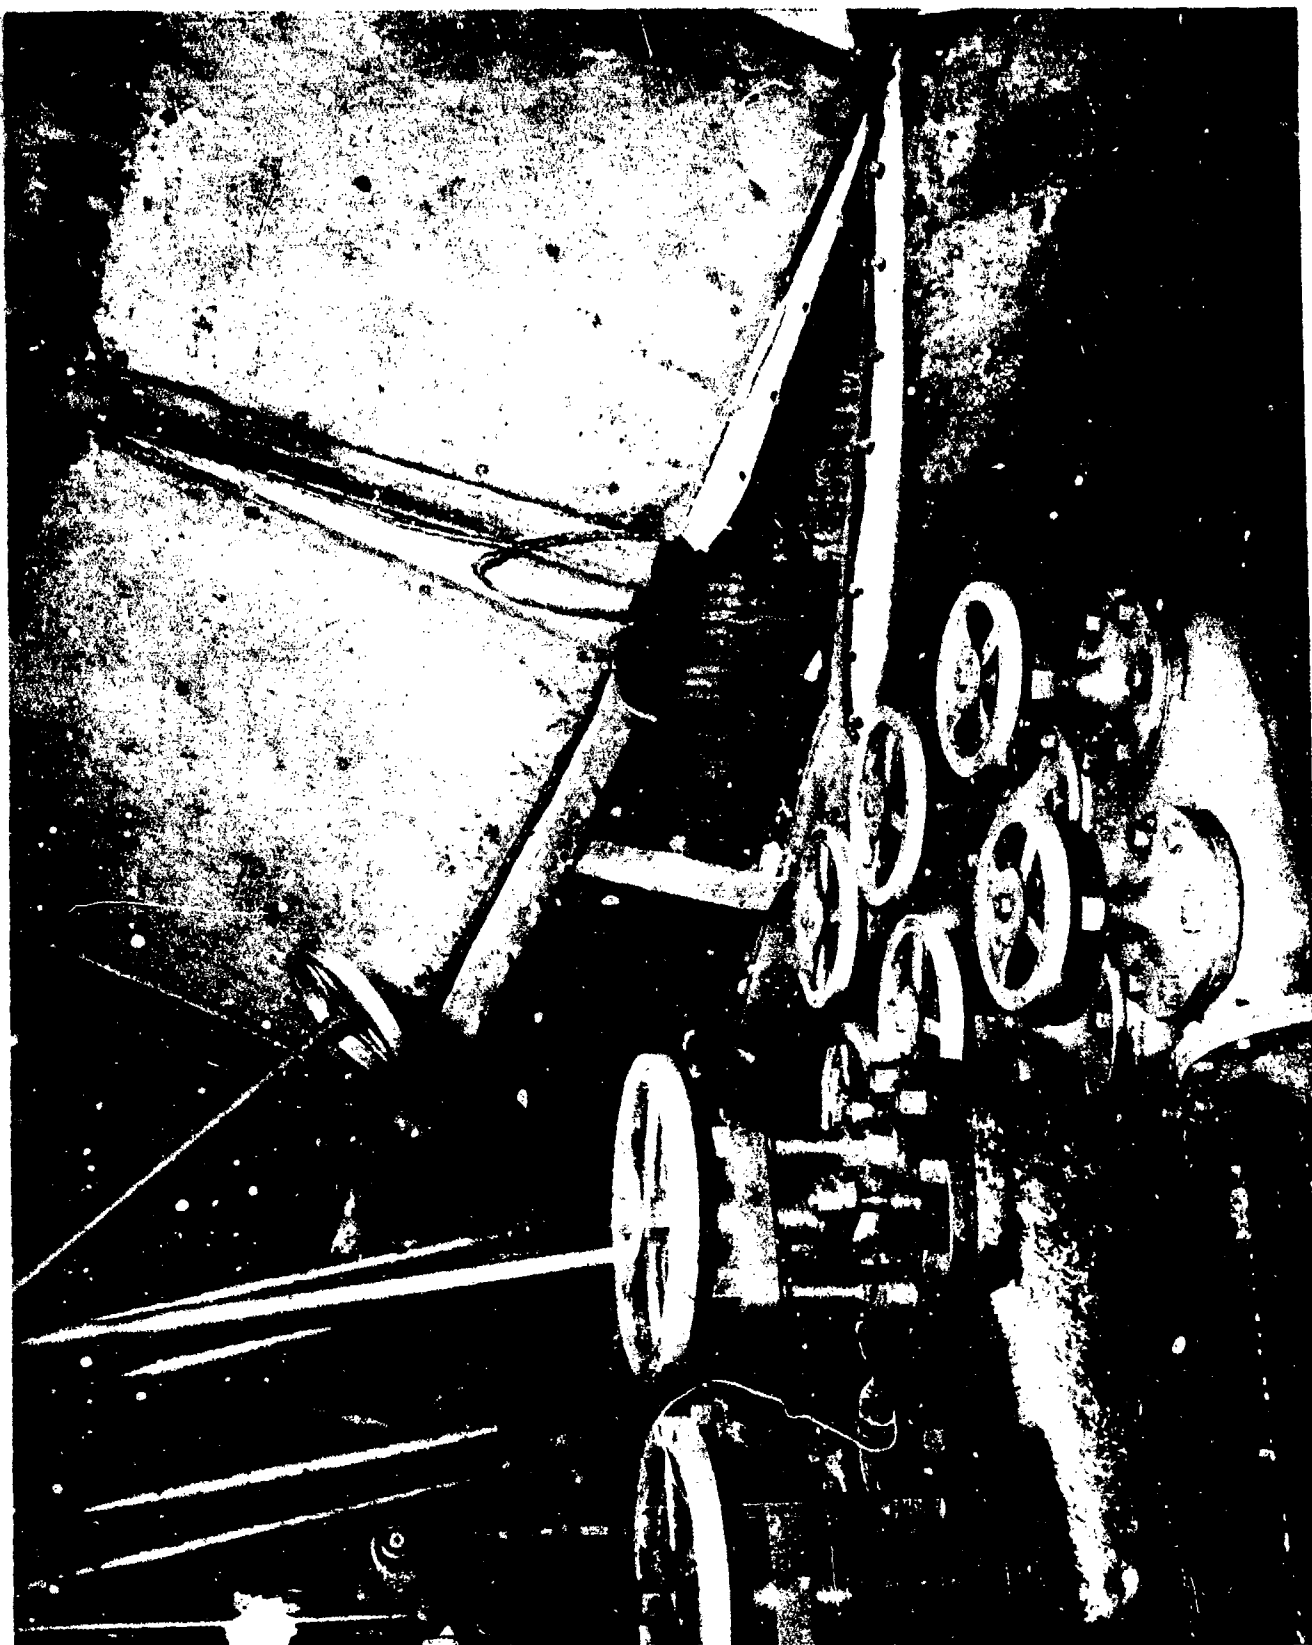
AB-CR-24-4060-2. No. 3 boiler casing.

Boiler casings ruptured in Test A are more severely buckled than before. The casings of boilers numbers 5 and 6, previously repaired, have again been ruptured. There is minor damage to brick and plastic in all boilers. The only other damage to equipment is from flooding. This would not have occurred had the ship been manned.
